⑥ Number
National Dam Inspection Program.
PA-468 Dam (NDI-I.D. PA-00046,
DER-I.D. 58-132, SCS-ID, PA-468),
SUSQUEHANNA RIVER BASIN,
BROOKLYN RUN, SUSQUEHANNA COUNTY,
PENNSYLVANIA. Phase I Inspection
Report,
Number ②

PHASE I INSPECTION REPORT

NATIONAL DAM INSPECTION PROGRAM

GANNETT FLEMING CORDDRY AND CARPENTER, INC.

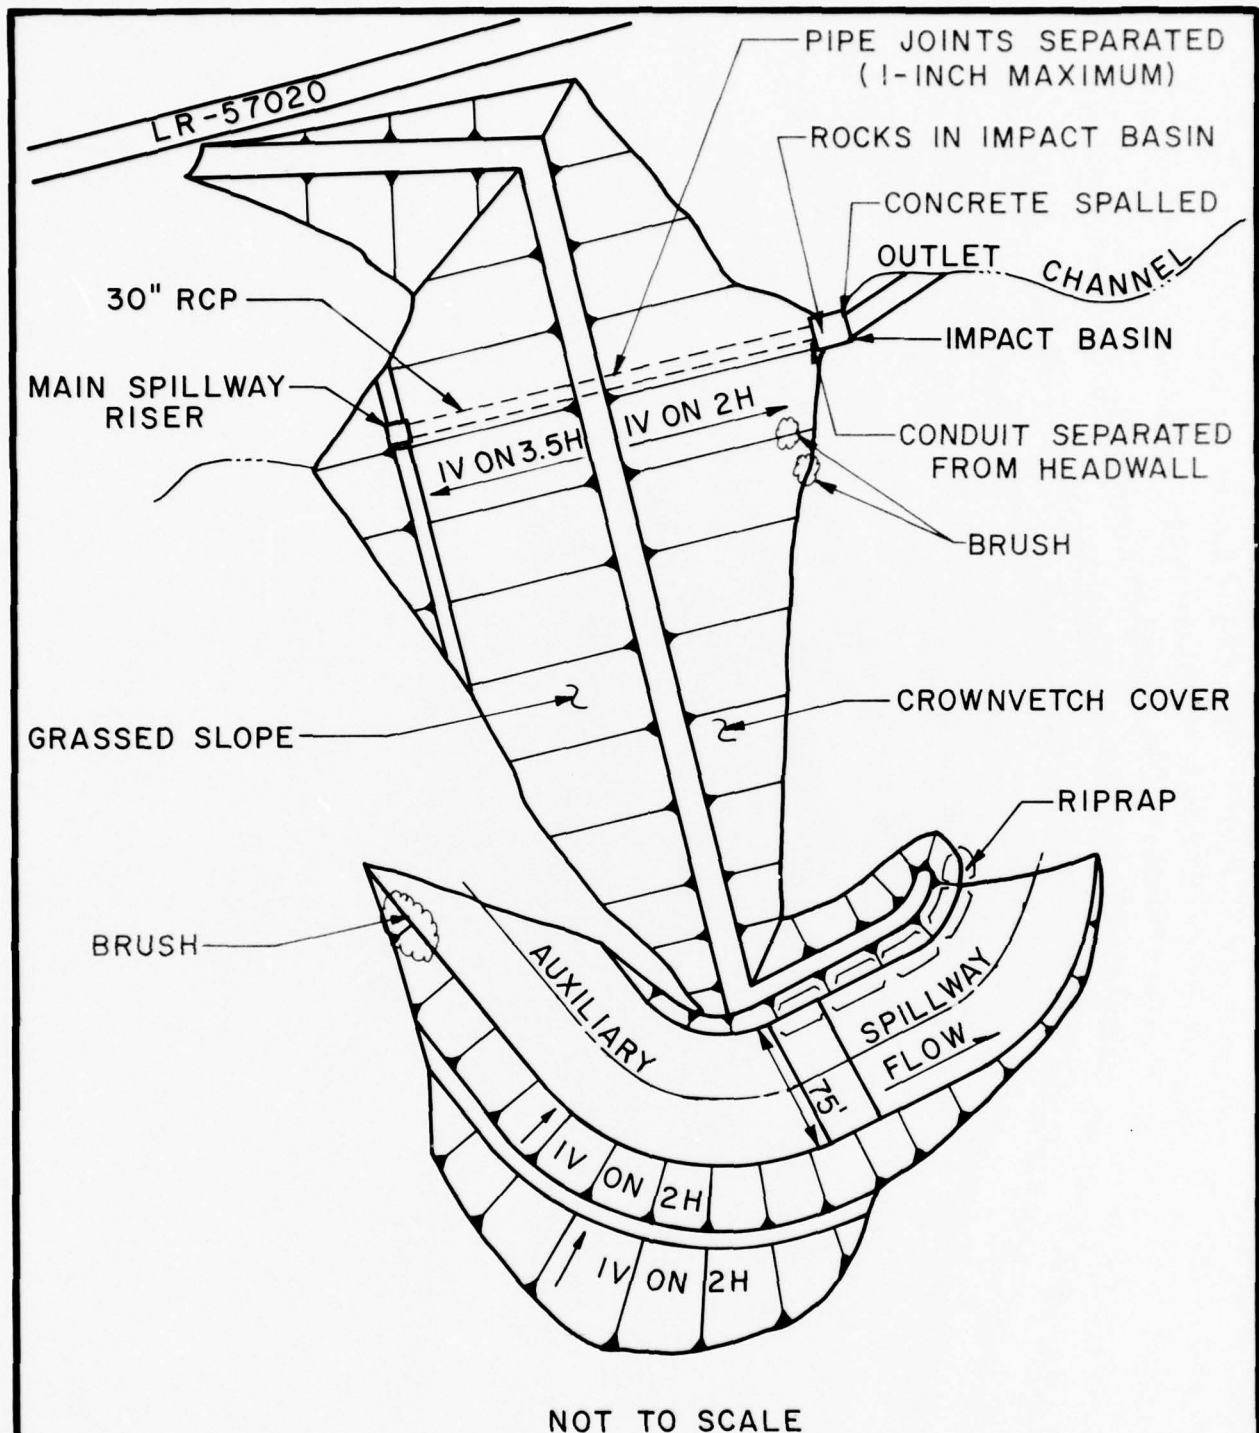
PHASE I INSPECTION REPORT
 NATIONAL DAM INSPECTION PROGRAM
 PA-468 DAM
 SUSQUEHANNA COUNTY COMMISSIONERS
 RESULTS OF VISUAL INSPECTION
 AUGUST 1979 PLATE B-1

a. General. The overall appearance of the dam is good with a few deficiencies as noted herein. The locations of deficiencies are shown in Appendix B on Plate B-1. Survey data acquired during this inspection are presented in Appendix B. Datum for the survey was assumed at the design elevation of the end sill of the impact basin, El. 1190.00. On the day of the inspection, the pool was 0.1 foot above the crest of the orifice in the main spillway riser.

<u>Feature and Location</u>	<u>Observed Deficiencies</u>
<u>Embankment:</u>	
Downstream Slope	Minor amount of brush.
<u>Main Spillway:</u>	
Conduit	Conduit joints separated; slight separation of conduit from impact basin headwall with slight, clear leakage.
Impact Basin	Rocks in impact basin; minor spalling of concrete.
<u>Auxiliary Spillway:</u>	Minor amount of brush.

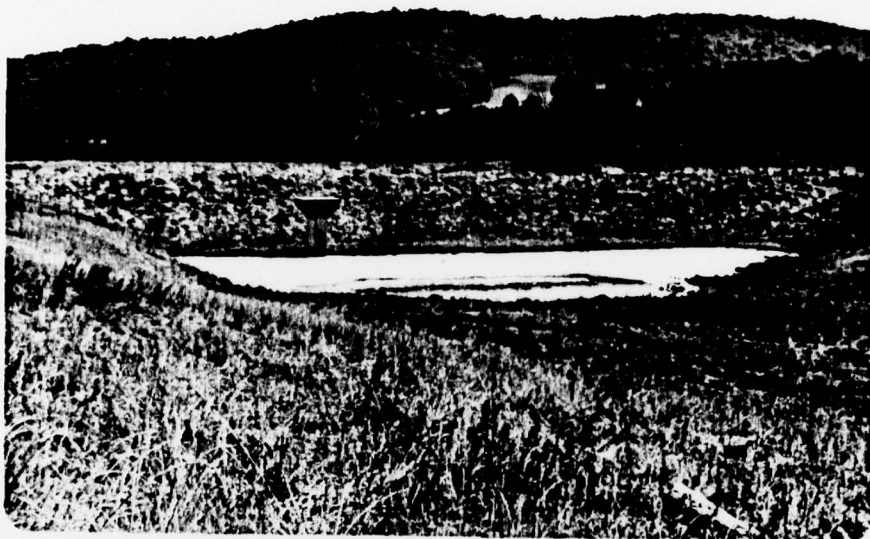
(2) Embankment. The slope protection on the upstream slope is dense grass. Although there is no riprap, the erosion potential due to wave action is minimal. The combination of small maximum pool (4.2 acres) and dense vegetal cover makes erosion unlikely. In addition, the good maintenance record for the dam indicates that any minor erosion that might occur would be repaired promptly.

A. Upstream Slope of Embankment.

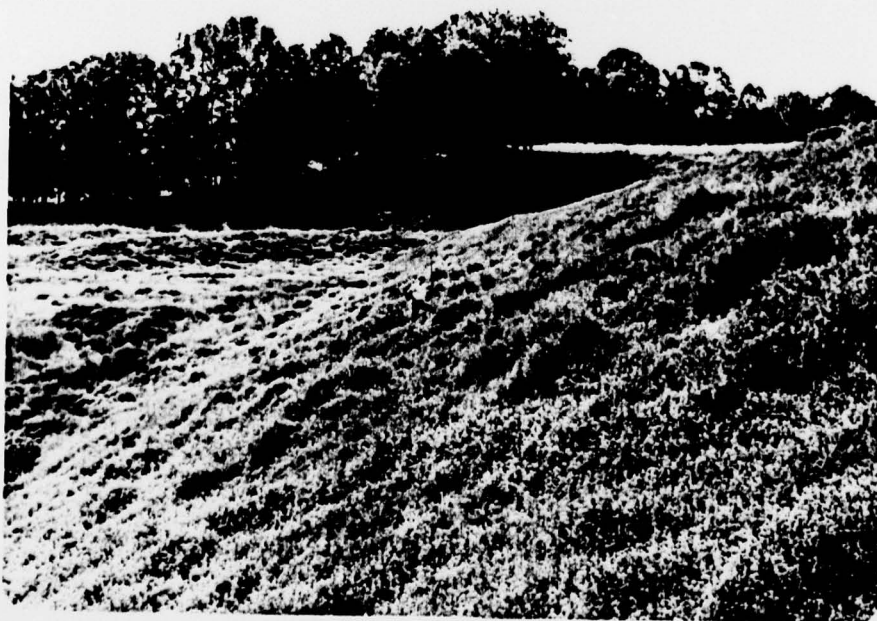
b. Embankment. The embankment is in good condition. The grass cover on the upstream slope and the crownvetch cover on the downstream slope are in excellent condition. There is no slope protection on the upstream slope other than the grass cover. A survey performed for this inspection showed that embankment lines and grades are in good conformance with the design lines and grades. Two foundation drain outlets, located at the impact basin, each had a slight, clear flow. Two small shrubs were growing on the downstream slope of the dam.

B. Downstream Slope of Embankment.

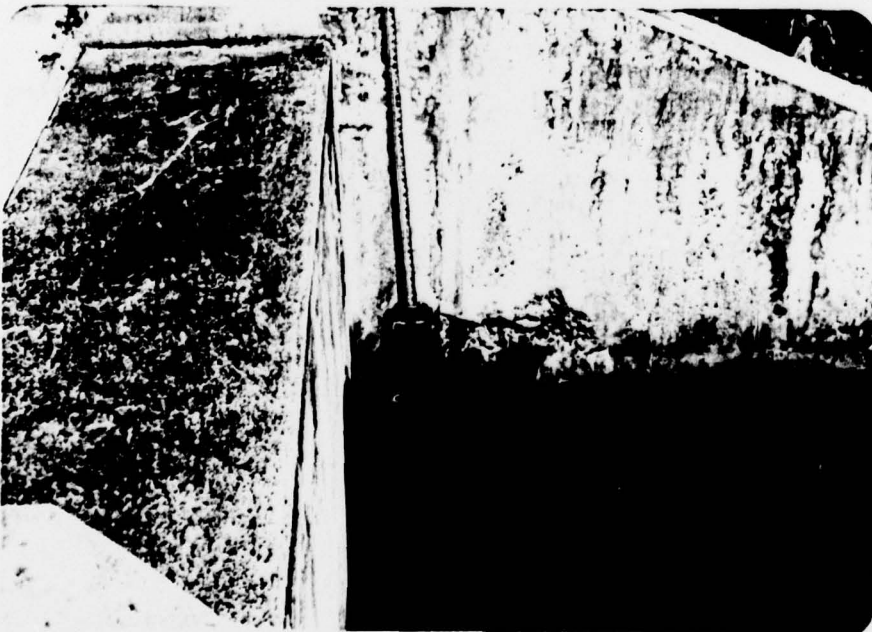
The main spillway riser was in good condition. The reinforced concrete outlet conduit was inspected and found to be in good condition. Joint separations, up to a maximum of 1 inch, were observed along the conduit. The joint separations were nearly zero at each end and increased progressively toward the maximum section of the dam. At its downstream end, the reinforced concrete outlet conduit was slightly separated from the impact basin headwall. A slight, clear flow of water was visible at the separation. The impact basin contained several large rocks, apparently the result of vandals. There was some minor spalling of the concrete along the inside of the left wall of the impact basin.

(3) Appurtenant Structures. Although joint separations as large as 1 inch were present in the 30-inch main spillway conduit, the Specifications indicate that the pipe joints have a minimum extensibility of 2 inches. Therefore, the joint openings are less than the allowable openings, and the joints should be watertight. The connection of the outlet conduit to the impact basin headwall is not watertight. Although this condition has apparently not resulted in any adverse effects, it is considered to be undesirable. Potentially adverse

conditions, such as possible loss of fine filter material, might occur under high head conditions. The large rocks in the impact basin are also considered to be undesirable. During periods of high spillway discharge, turbulence might cause the rocks to damage the impact basin. The amount of brush in the auxiliary spillway is not significant at the present time, but control of it is necessary to insure that no reduction of spillway capacity occurs.

D. Main Spillway Impact Basin
and Foundation Drain Outlet.

(2) Make repairs necessary to eliminate the separation and leakage between the main spillway conduit and the impact basin headwall.

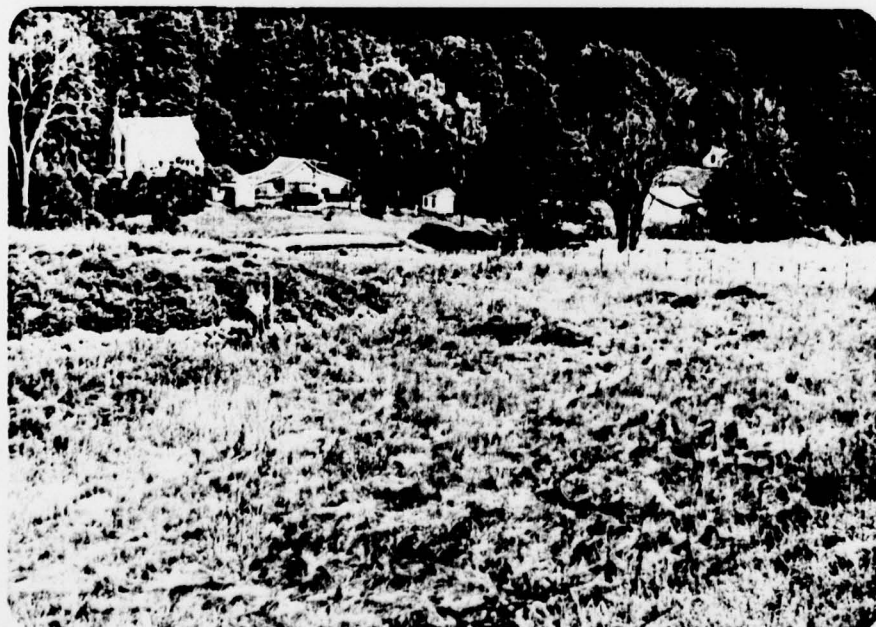
F. Auxiliary Spillway Exit Channel.
